Review Article

Optimizing contrast enhanced mammography: A comprehensive review of artefacts, causes, and remedies

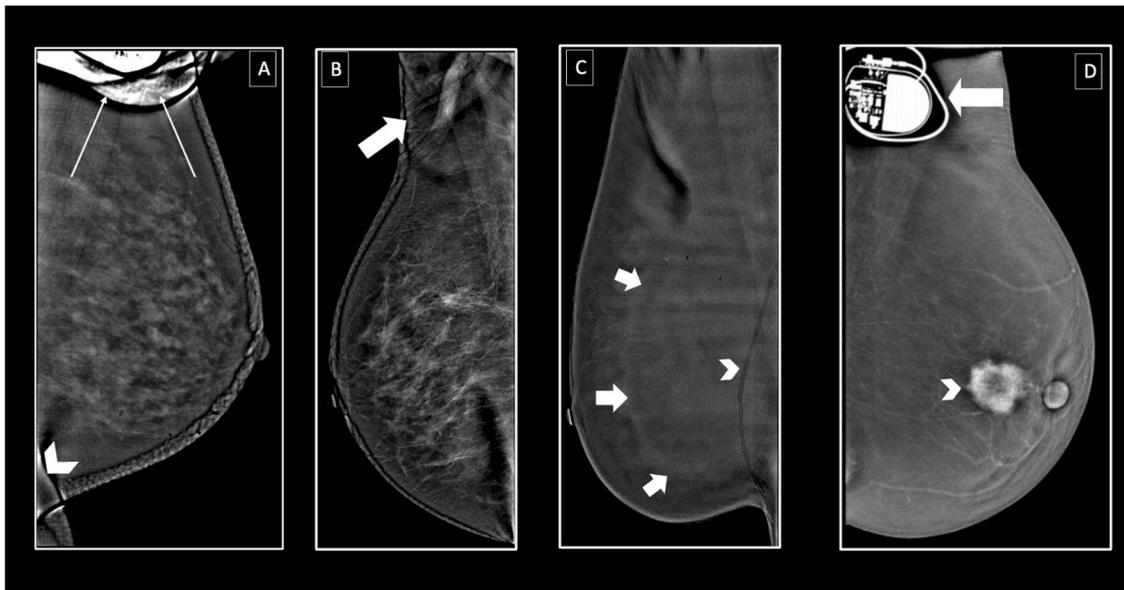
Fig. 1. Overlay artifact; contrast enhanced mammography images in different patients. **A** Mediolateral oblique view, recombined image of the left breast in a 56-year-old woman shows a radiopaque structure obscuring the upper axilla due to overlay of the patient’s chin (white arrows). The abdomen is also seen overlying the inferior and posterior breast (white arrowhead). **B**, Mediolateral oblique view, recombined image of the right breast of a 64-year-old woman show curvilinear lines over the axilla (white arrow), consistent with a hair artifact. **C**, Mediolateral oblique view, recombined image of the right breast in a 48-year-old woman show a tubular structure along the posterior breast, consistent with a ventriculoperitoneal shunt (white arrowhead). Additionally, a "breast within breast" artifact is also noted (white arrows). **D**, Mediolateral oblique view, recombined image of the left breast in a 67-year-old woman shows a radiopaque pacemaker overlying the left axilla with a surrounding black halo on the recombined image consistent with overlay and high attenuation artifacts. In addition, a high density irregular mass showing heterogeneous enhancement on the recombined image is seen in the retroareolar location (arrowhead) with associated nipple retraction. On histopathological examination (HPE) and immunohistochemistry, the mass was Luminal B infiltrating ductal carcinoma, non-specific type, Grade II.

external objects or anatomic structures such as hair, chin, shoulder, contralateral breast, or clothes in the field of view. Even internal placements of ventriculoperitoneal shunts and pacemakers may superimpose the breast parenchyma and hinder accurate image interpretation (Fig. 1).

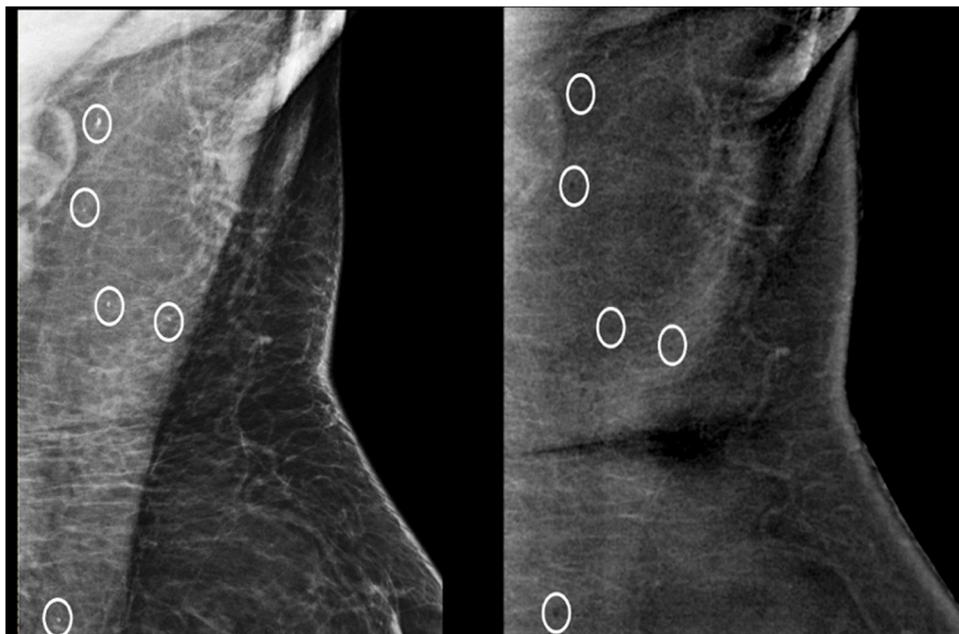
Fig. 2. Antiperspirant artifact; contrast enhanced mammography images in a 58-year-old woman with invasive ductal carcinoma. Low energy image (left) of the left axilla (zoomed-in) showing hyperdense punctate foci due to antiperspirant; recombined image (right) of the left axilla (zoomed-in) shows the antiperspirant as small black dots (white circles).

Antiperspirants induced artifacts. Many antiperspirants contain high atomic number aluminium compounds, which behave similar to calcium with respect to their X-ray attenuation properties. Their residue on the breast surface appears as tiny bright spots on the LE image with corresponding dark spots on the RC image (Fig. 2). These can be mistaken for calcifications if the radiologist is not aware of their imaging appearance.

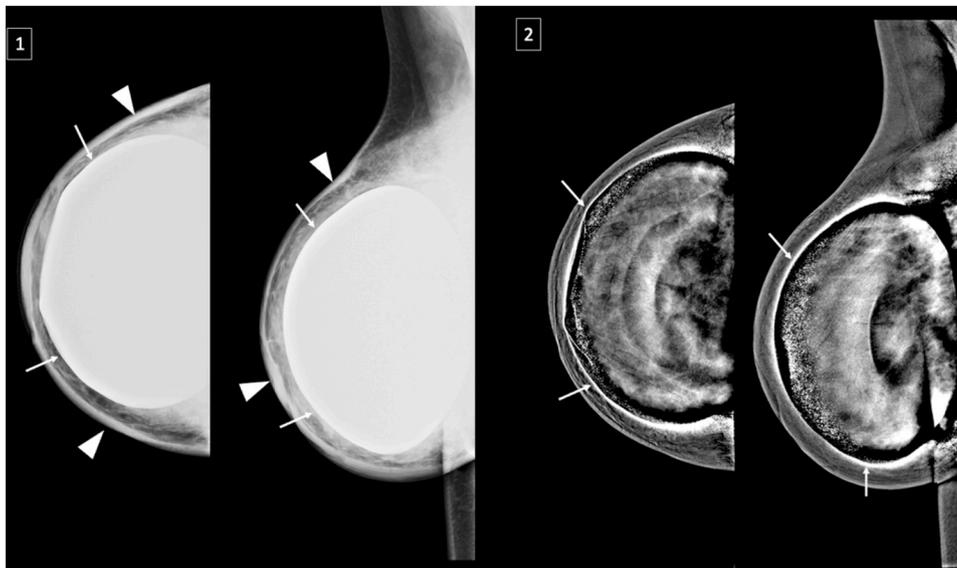
Fig. 3. Breast implant artifact; contrast enhanced mammography performed for new onset swelling in the right breast in a 49-year-old woman with an implant. 1, Craniocaudal and mediolateral oblique views, low energy images show a breast implant in situ (white arrows) with diffuse thickening of the skin (arrowheads). 2, Craniocaudal and mediolateral oblique views, recombined images show postprocessing artifact as a bright white band adjacent to the implant.

Breast implant induced artifacts. The differential attenuation of the X-ray by the silicone and saline breast implants or their capsular calcifications affects postprocessing algorithms and results in inaccurate subtraction. This creates peri-implant white or black bands in RC images that may potentially obscure an underlying pathology.⁵⁻⁸ (Fig. 3)

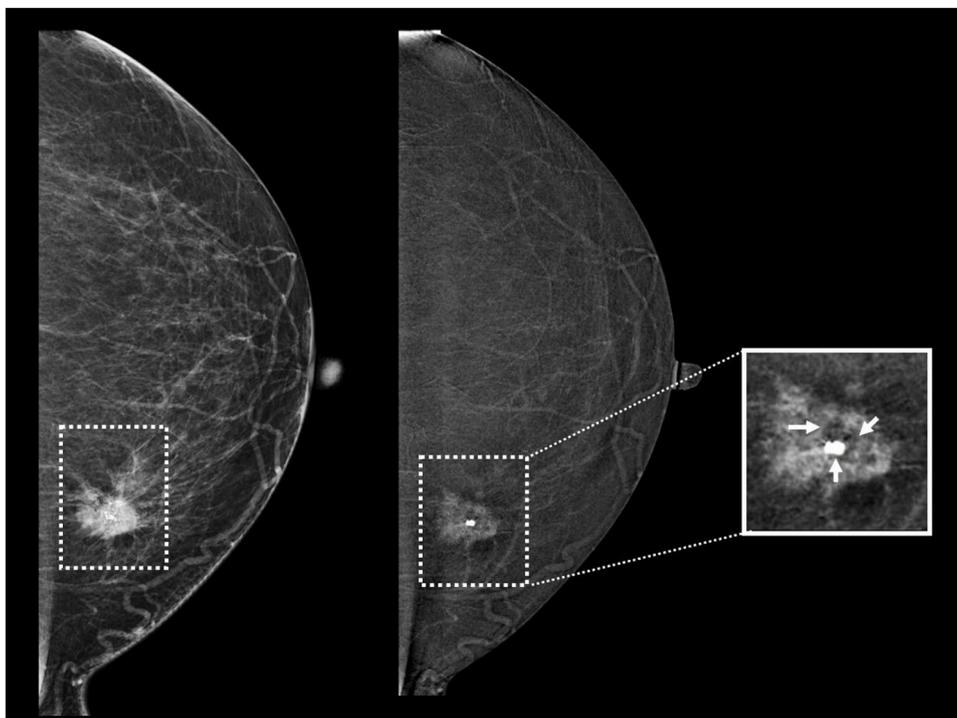
Fig. 4. Artifact due to hyperdense surgical clip/marker; contrast enhanced mammography images from a 54-year-old patient with left invasive breast cancer on chemotherapy. Craniocaudal view, low energy image (left) of left breast showing a high density spiculated mass with fine pleomorphic calcifications and a pre-chemotherapy radio-opaque marker clip placed inside it; Craniocaudal view recombined image (right) showing dark rim surrounding the marker (white arrows) that is inside the heterogeneously enhancing mass.

High density artifact caused by surgical clips/markers and dense calcifications. Titanium or zirconium oxide clips or markers are usually used in the breast after biopsy or before starting neo-adjuvant chemotherapy. The sharp contrast between the high attenuating markers/calcifications and lower attenuation of the surrounding breast, caused by significant X-ray scatter, creates a distinct dark rim surrounding them in RC images.⁹ (Fig. 4)

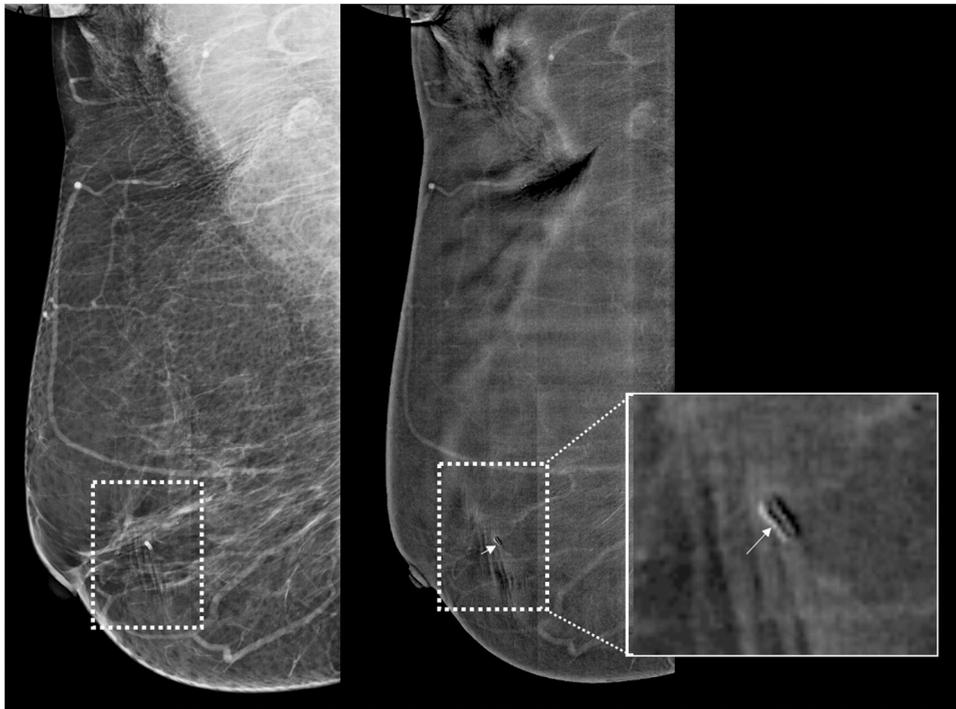
Fig. 5. Misregistration artifact; contrast enhanced images of a 49-year-old woman with papillary neoplasm in the contralateral breast. Mediolateral oblique view of right breast, low energy image (left) shows benign calcification in the retroareolar location and recombined image (right) shows incomplete subtraction with a bright line at the interface of the calcification, giving a 'zebra like' appearance (white arrow).

Misregistration artifacts - Subtle patient movement between LE and HE images results in misalignment and produces misregistration artifacts on recombined images due to inaccurate subtraction. This manifests as blurring of the margins, particularly around the microcalcifications, markers, and small surgical clips, giving rise to alternate dark and bright lines, referred to as "zebra lines" (Fig. 5). These may obscure microcalcification or small masses and cause interpretation errors. These artifacts are more often encountered in the mediolateral oblique (MLO) projection due to the lack of support to the breast from the bucky tray.^{5-7,12}

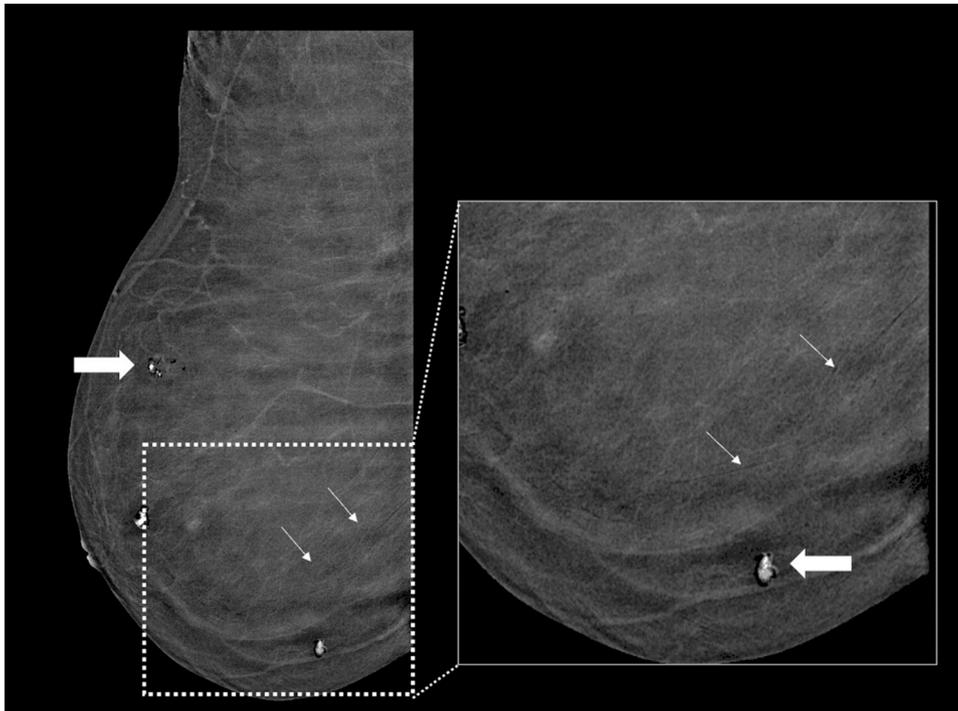
Fig. 6. Ripple artifacts; contrast enhanced mammography in a 44-year-old woman with metaplastic carcinoma in the contralateral breast. Mediolateral oblique view, recombined image of the right breast, showing wavy alternate black lines along inferior and posterior breast (thin white arrows), consistent with ripple artifact. Note is also made of incidental involuted fibroadenomas (block arrows) showing the misregistration artifact.

Ripple artifacts - These are attributed to both fine patient movement during acquisition as well as due to transmitted respiratory motions and cardiac pulsations. They manifest as thin, alternating white and black lines on recombined images (Fig. 6). These artifacts are particularly common in the lower part of MLO views of the left breast due to relatively weak compression and a more pronounced effect of cardiac pulsations.⁷⁻⁹

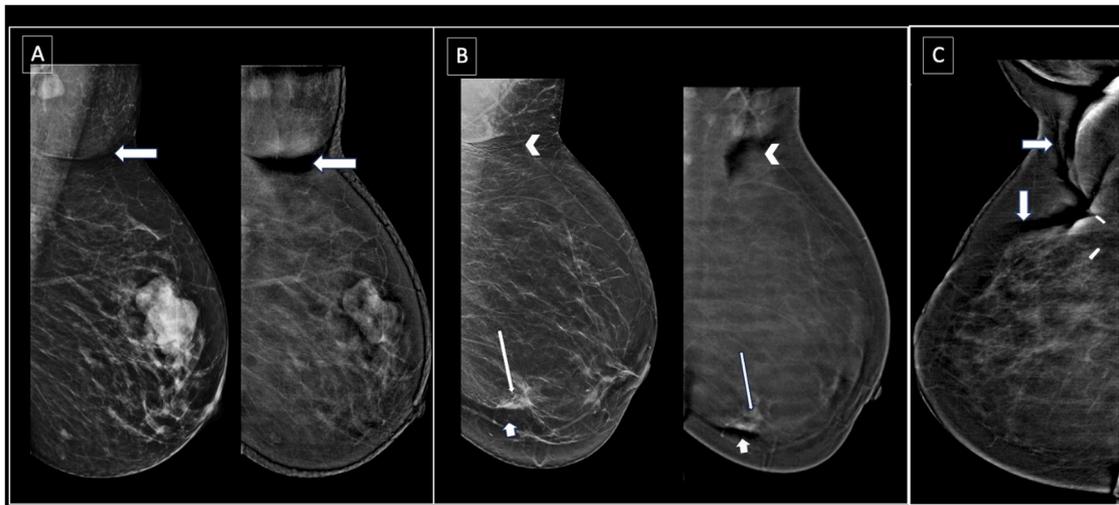
Fig. 7. Air Trapping artifacts; contrast enhanced mammography images in multiple patients. **A,** Mediolateral oblique view low energy (left) and recombined images (right) of the left breast in a 51-year-old patient with prominent axillary fat pad depict a linear low-density in the axillary region secondary to air trapping (white block arrow). **B,** Mediolateral oblique view, low energy (left) and recombined images (right) of the left breast in a 57-year-old woman with invasive ductal carcinoma (long arrow) depicts air-trapping artifact (short block arrow) due to skin retraction adjacent to the heterogeneously enhancing spiculated high density mass (long arrows). Note is also made of air-trapping artifact in the axilla seen as black line (arrowhead). **C,** Mediolateral oblique view, recombined image of right breast of a 46-year-old woman, status post-lumpectomy for previous carcinoma breast depicts air-trapping artifact due to lack of contact between the skin and the detector/ compression paddle leading to air entrapment between scar folds (white arrows).

attenuation of X-rays compared to the surrounding breast tissue, creating dark lines, particularly in the axillary and inframammary regions (Fig. 7). This problem is more prevalent in post-lumpectomy and obese patients who have multiple prominent skin folds. These artifacts occur in both low-energy (LE) and recombined (RC) images but are accentuated in RC images during image processing. These can obscure smaller masses and negatively impact image interpretation.^{7,9}

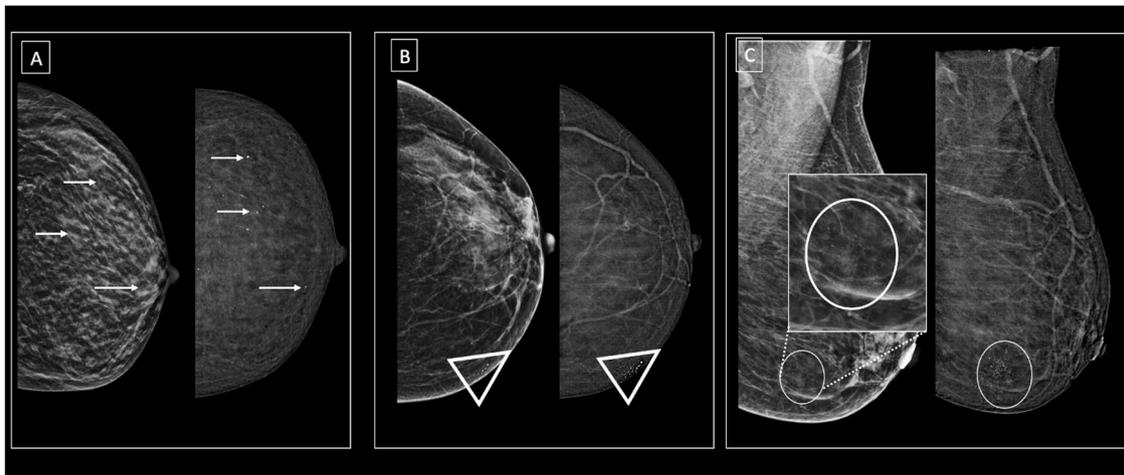
Fig. 8. Contrast Splatter artifact; contrast enhanced mammography images from different patients. **A**, Craniocaudal view, low energy (left) and recombined images (right) of left breast in a 41-year-old woman show multiple high attenuation foci (white arrows) appearing as pseudocalcifications on low energy image (left), which are not subtracted and remain hyperattenuating on the recombined image (right), consistent with contrast splatter artifact. **B**, Craniocaudal view, low energy (left) and recombined (right) images of left breast in a 55-year-old woman shows non-anatomic high attenuating foci on the skin, consistent with contrast splatter artifact. **C**, Mediolateral oblique view, low energy (left) and recombined images (right) of left breast in a 48-year-old woman showing contrast splatter giving dot-dash appearance and mimicking grouped calcifications. It is pertinent to note that contrast splatter appears white on both low energy and recombined images, whereas calcifications appear white on low energy images and black on recombined images.

Contrast splatter artifact or contamination artifact – These may be caused by contamination of the gloves of the technologist with contrast or by inadvertent spillage of contrast onto the breast surface,

compression paddle, or detector. The contrast agent causes greater attenuation of X-rays in comparison to the rest of the breast tissue, resulting in the appearance of bright spots on the RC images. Due to its higher concentration, the surface contrast can also be visible on LE images, whereas, typically, intravenous contrast is primarily visible on RC images. Such areas may mimic pseudocalcifications or appear as abnormal non mass enhancement to the reader (Fig. 8). However, their non-anatomic distribution and morphology are often clues to the diagnosis. Moreover, contrast splatter is bright on both LE and RC images, while calcifications are white on LE images and usually black on RC images (Fig. 9). Also, contrast splatter appears intensely bright on the RC image and resolves on cleaning the surface.⁵⁻¹⁰

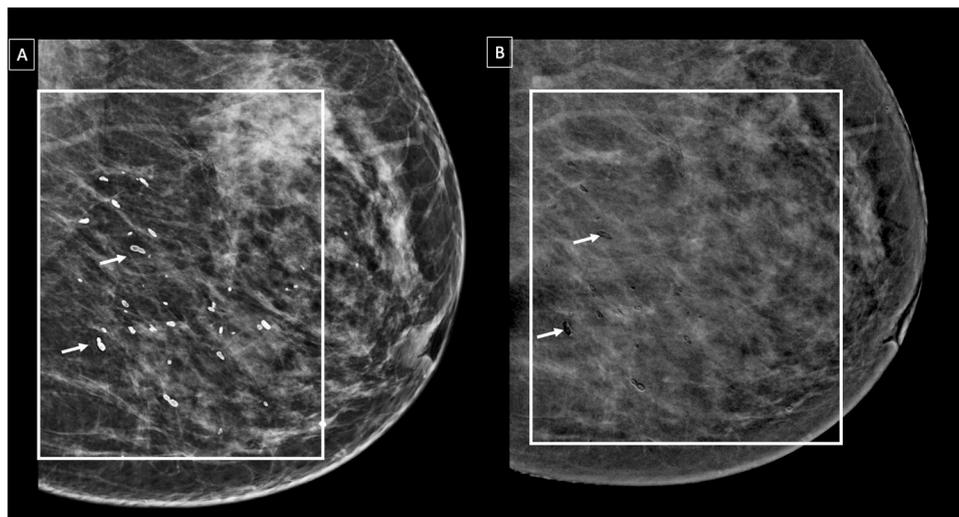
Fig. 9. Contrast enhanced images in a 56-year-old woman, zoomed-in low energy image (left) of left breast depicting benign calcifications in a regional distribution, zoomed-in recombined image (right) showing subtraction of these calcifications (white arrows).

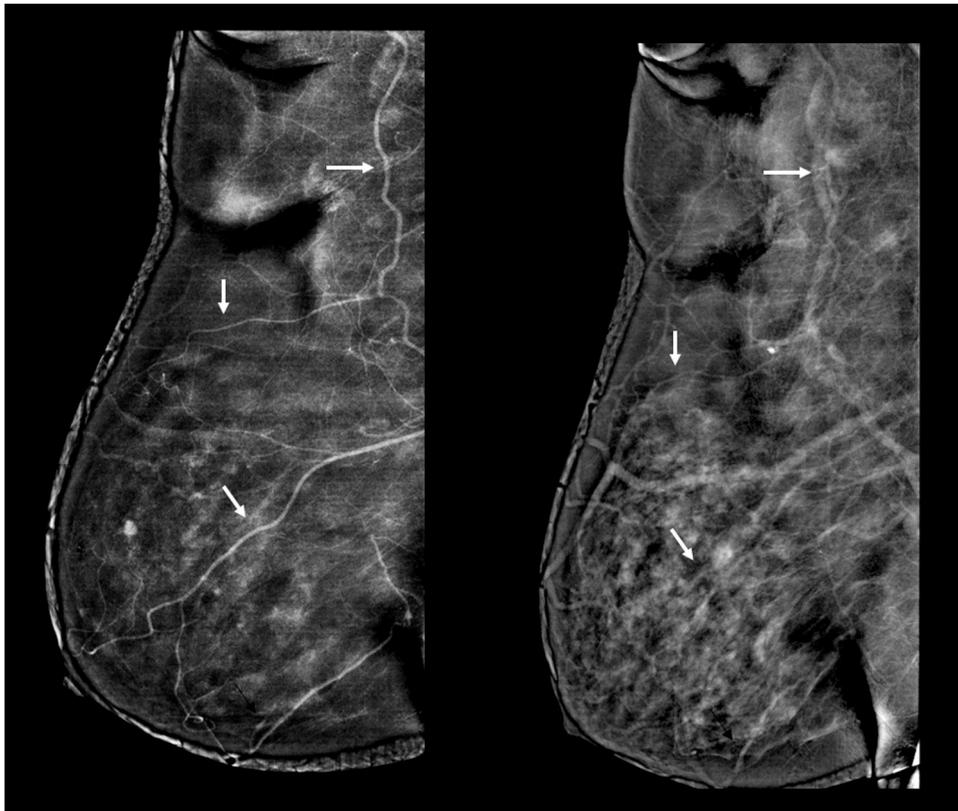
Fig. 10. Transient retention of contrast in the vessels; contrast enhanced mammography images in a 45-year-old woman. Mediolateral oblique view, recombined image (left) showing avid enhancement of the vessels, with contrast retention prior to significant dissipation into the breast parenchyma (white arrows). Subsequent acquisition of recombined image (right) shows contrast uptake in the breast parenchyma with dissipation of contrast from the vessels which appear less dense.

contrast has sufficient time to reach the breast tissue can restrict contrast distribution into the breast. This artifact is transient and usually disappears in later images (Fig. 10). However, a prolonged presence of the contrast within the vein, even after 10 minutes of injection, may indicate a central venous thrombosis and needs further evaluation and management.^{7,9,12}

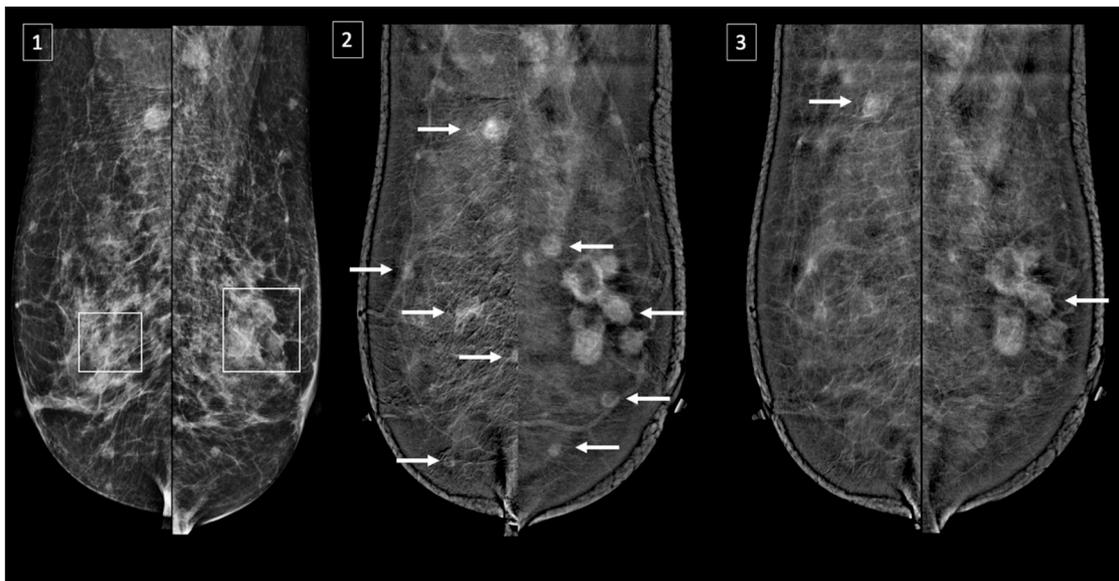
Fig. 11. Injection Synchronization Error; contrast enhanced mammography images of a 61-year-old woman with bilateral breast metastases from papillary thyroid carcinoma. (1) Bilateral mediolateral oblique low energy images reveal asymmetric breast parenchyma on comparison of both breasts, along with associated bilateral axillary lymphadenopathy. (2) Recombined images at 2 and 3 minutes after contrast injection show multiple enhancing masses in both breasts (white arrows). (3) Recombined image at 10 minutes after contrast injection show contrast washout from the previously visible masses, which now appear faint and indistinct. This emphasizes the critical need to capture images within the optimal time window as failure to do so can result in missing significant lesions, leading to an incomplete or misleading assessment of disease extent.

Injection Synchronisation Error Artifact - It occurs when there is a mismatch between the timing of contrast injection and image acquisition due to various patient factors or technical reasons. If the imaging is performed outside the stipulated window (typically starting 2 minutes after contrast injection and completing within 8-10 minutes), the contrast may not have adequately perfused or may have dissipated from the breast tissue, resulting in suboptimal enhancement and false negative interpretations.¹² (Fig. 11)

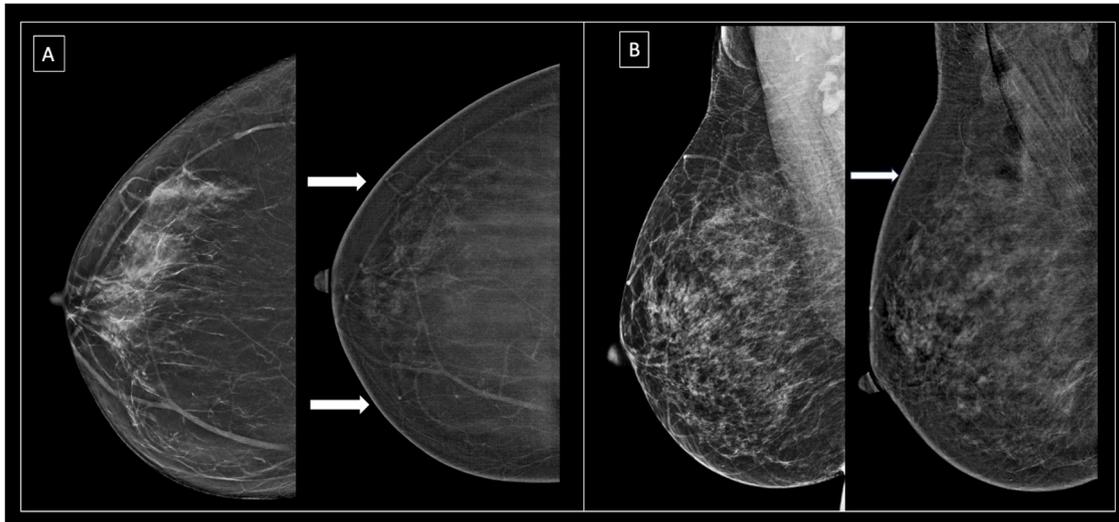
Fig. 12. Skin line enhancement artifact; A, Craniocaudal view, low energy image (left) of right breast in a 43-year-old woman showing normal skin thickness and recombined image (right) showing enhancement along the skin line mimicking skin thickening (block arrow). B, Mediolateral oblique view, low energy image (left) of the right breast in a 58-year-old woman showing normal skin thickness, however, there is apparent skin thickening with enhancement (white block arrow) on the recombined image (right).

This has also been described as a ‘skyline artifact’ in the literature.⁵⁻¹⁰ There is non-uniform scattering of the radiation over the surface of the breast due to variable thickness of the skin, which manifests as a bright skin line or pseudo-enhancement of the skin on the RC images

(Fig. 12). This enhancement can be mistakenly interpreted as abnormal skin involvement, potentially leading to an incorrect upstaging of the disease.^{7,9,12}

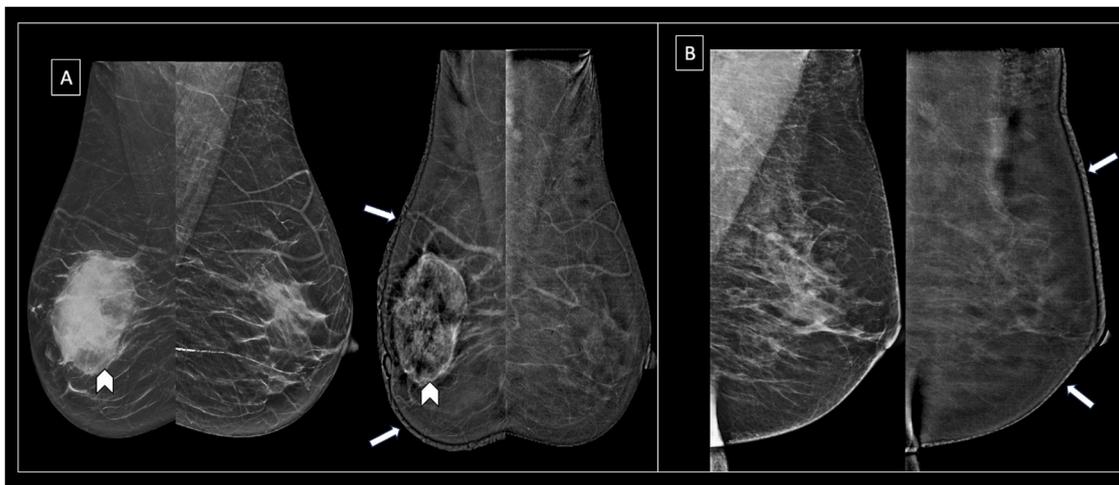
Fig. 13. Tree bark artifact; A, Contrast enhanced mammography images in a woman with histopathologically proven triple negative invasive ductal carcinoma. Mediolateral oblique view, low energy image (left) of right breast shows oval high-density mass (arrowhead) with normal skin thickness of the right breast. Recombined image (right) of right breast shows apparent skin thickening resembling tree bark (white block arrows). Note is made of heterogeneous enhancement of the mass (white arrowheads). B, Contrast enhanced images from another patient showing no significant abnormality on low energy image, with fallacious skin thickening on recombined image (white block arrows), Comparison with the low energy images will help in confirming if the skin thickening is artifactual or definite.

This artifact is the result of detector saturation, likely secondary to overexposure, excessive X-ray scatter at the skin surface, with equalisation of pixel values between the skin and adjacent breast tissue. This process causes the skin line to blur or disappear on LE images and creates a false appearance of skin thickening on RC images, resembling the texture of tree bark.^{8,9,15} (Fig. 13)

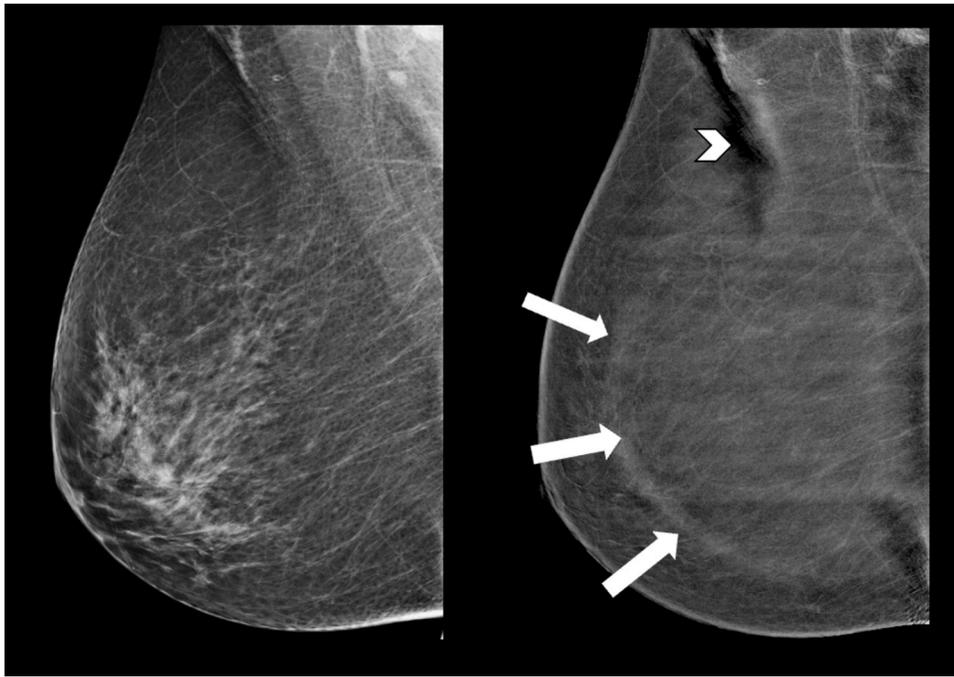
Fig. 14. Halo artifact/ breast-in-breast artifact; contrast enhanced images in a 47-year-old woman. Mediolateral oblique view, low energy image (left) showing normal breast parenchyma and recombined image (right) showing a C-shaped white line creating a rim-like artifact, seen parallel and posterior to the skin line, mimicking a breast-within-breast appearance (white block arrows). Additionally, air trapping artifact (white arrowhead) is also seen in the axilla.

This is one of the most prevalent artifacts in CEM studies.^{14,16} It has also been referred to as a 'Rim/Scatter Radiation' artifact in literature.^{7,9,14,16} This appears as a uniform, convex, high-density line parallel to the skin at the boundary between pre-mammary fat and fibroglandular tissue, causing a double contour appearance on RC images (Fig. 14). It is primarily caused by variable scatter of the X-rays due to an abrupt change in thickness of the central and peripheral breast regions, causing the processing algorithm to create a fallacious boundary. Yagil et al., also suggested that this artifact could be the result of differential contrast absorption in the outer breast due to reduced compression and a more abundant blood supply in these regions.¹⁶ This artifact usually doesn't affect the image interpretation.

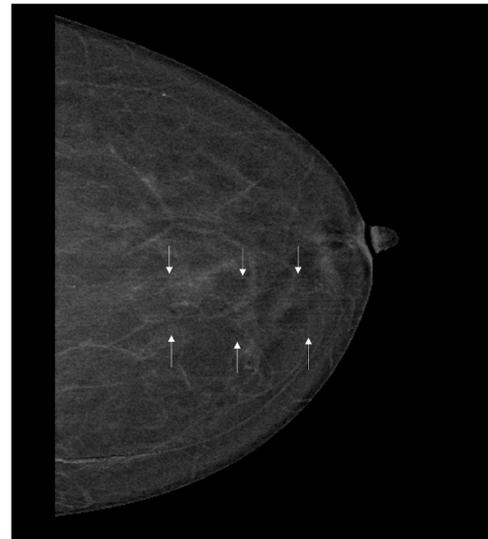
Fig. 15. Vibration artifact; Craniocaudal view, recombined image of left breast in a 41-year-old woman shows horizontal parallel lines extending across the breast (white arrows).

It manifests as horizontal black lines or alternate black and white lines in digital as well as RC images (Fig. 15). This artifact is likely caused by vibrations from the detector’s cooling fans, leading to

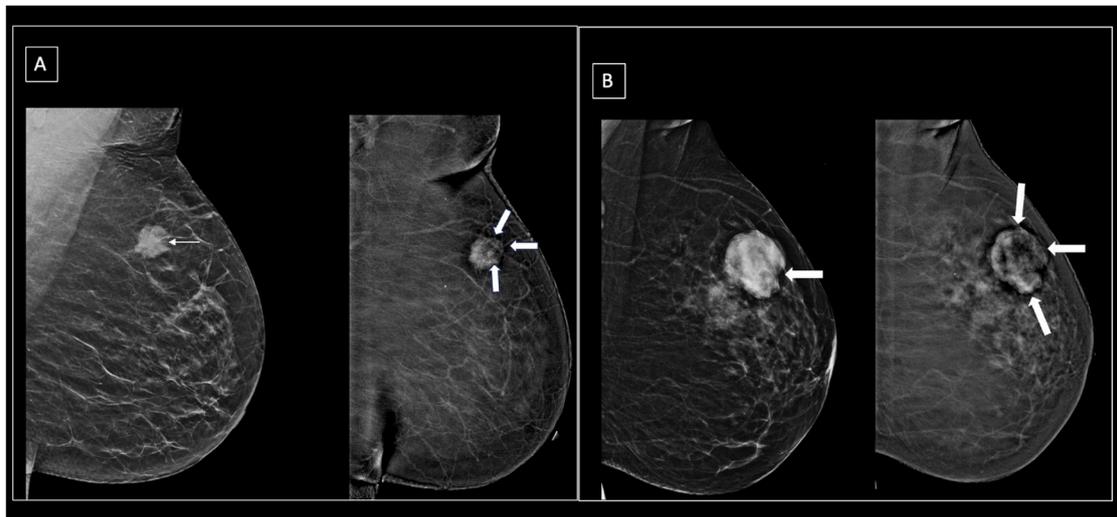
Fig. 16. Negative-rim artifact; **A,** Contrast enhanced mammography of a 51-year-old woman, mediolateral oblique view, low energy image (left) showing high-density mass with spiculated margin (white arrow) seen in the upper breast. In the recombined image (right) the mass shows heterogenous post contrast enhancement with surrounding negative-rim artifact (white block arrows), seen as black line around the mass. **B,** Contrast enhanced mammography of a 55-year-old woman, mediolateral oblique view, low energy image (left), of the left breast shows high density mass with circumscribed margins in the upper breast. In the recombined image (right) there is a dark negative-rim artifact surrounding the heterogeneously enhancing mass (white block arrow) due to differential attenuation and scatter at the edges of denser mass.

This artifact presents as a dark rim around enhancing masses on recombined images. It is likely caused by differential attenuation and pronounced scatter at the edges of denser structures, in addition to post-

processing effects that exaggerate the contrast at the interface (Fig. 16). This phenomenon is particularly evident around irregular or lobulated masses. Notably, this artifact has not been documented in prior studies. This artifact may obscure subtle details surrounding the mass.

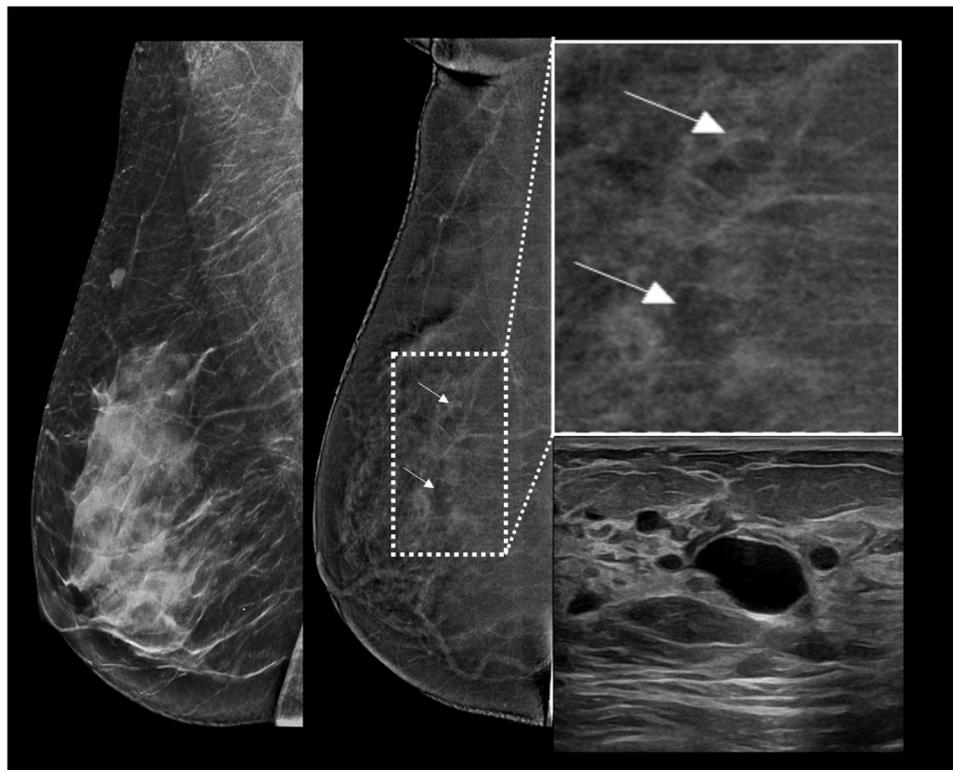
Fig. 17. Negative contrast enhancement/ Eclipse sign; Negative contrast enhancement in cysts, contrast enhanced mammography and ultrasound images in a 42-year-old woman who had presented with mastalgia and had positive family history for breast carcinoma. Medioloateral oblique view, low energy image (left) of the right breast reveals heterogeneously dense breast; recombined image and digitally zoomed image (right) show negative enhancement due to cysts seen as low-density areas (white arrows); correlative ultrasound image (lower right corner) depicting multiple thin-walled anechoic cysts scattered in the breast parenchyma.

Negative contrast enhancement/Eclipse sign/Crescent sign

This is caused by cysts, hematomas, coarse calcifications, and certain non-enhancing masses. These get completely subtracted in the recombined images and appear as darker low-density areas within the breast parenchyma in comparison to the surrounding enhancing fibroglandular tissue (Fig.s 17,18). This cannot be considered a true artifact and does not compromise the quality of the study.⁷ An important point to note is that malignant lesions showing negative contrast enhancement have a

thick, nodular, or irregular rim, whereas benign cysts may show an absent or smooth-enhancing rim.

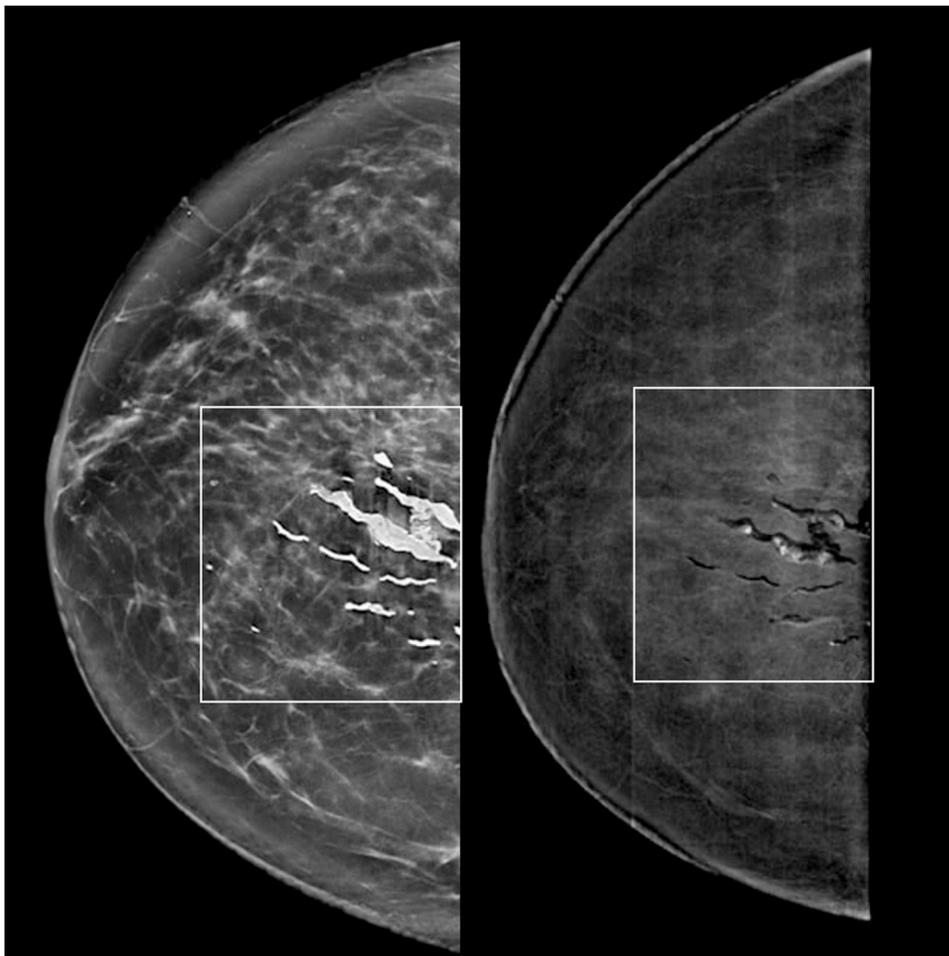
Fig. 18. Negative contrast enhancement in coarse calcification; contrast enhanced images in a 72-year-old woman, craniocaudal view, low energy image (left) of the right breast depicts extensive dystrophic calcification in the posterior third of the breast and recombined image (right) showing subsequent subtraction of the dystrophic calcification appearing dark, with some misregistration artifacts (bright areas at interface).

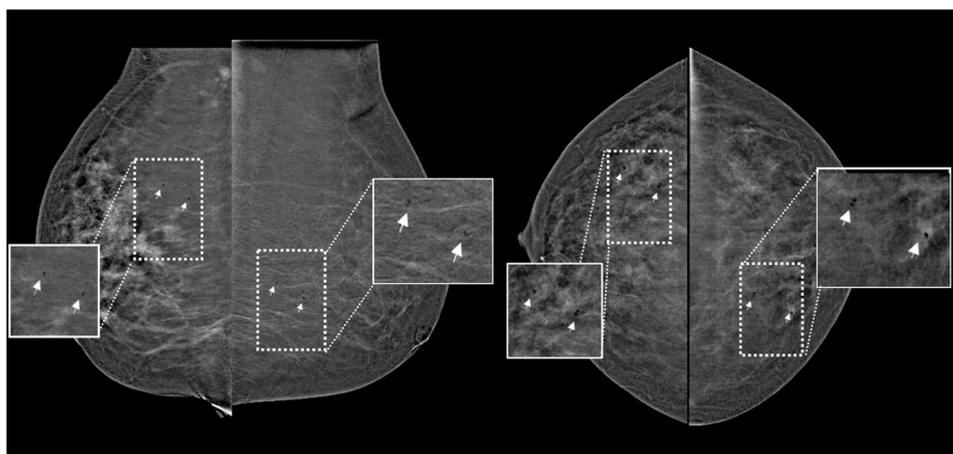
Fig. 19. Defective pixel artifact; Recombined images in two different patients (left and right), showing black dots (arrows) having identical morphology seen at corresponding matching locations, consistent with defective pixels. The artifact was corrected after detector recalibration.

Defective pixel artifact

Digital mammography detectors are composed of an array of pixels that convert X-ray signals into electrical signals, which are then processed to form an image. Defective pixel artifacts occur when individual pixels or groups of pixels in the detector array malfunction, leading to dark or bright spots in the low energy image. These are accentuated on

the recombined images during the processing, appearing as persistent dark spots in the images (Fig. 19). The cause is usually prolonged usage, wear and tear resulting in pixel degradation or electronic failure.^{18,19}

Remedy: Detector calibration, which automatically detects and compensates for the defective pixels by interpolating the data from the neighbouring pixels.

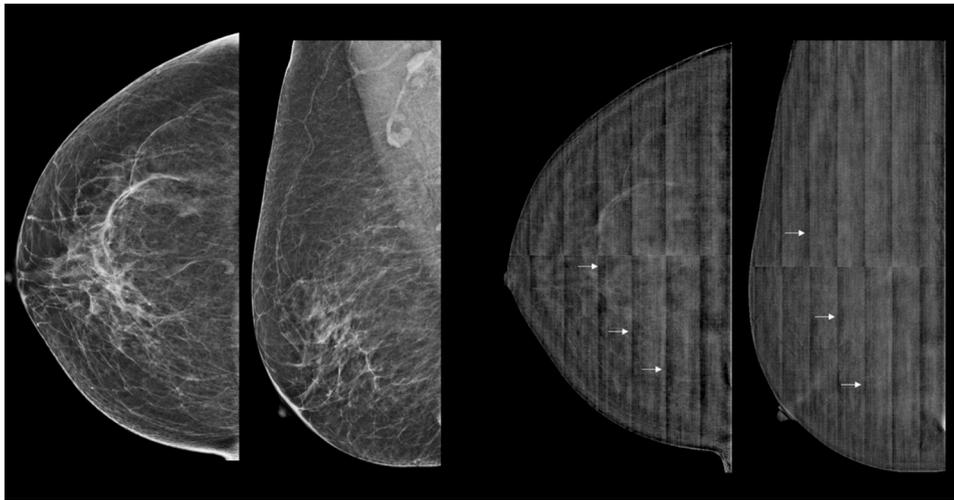
Fig. 20. CEM gain calibration artifact; Craniocaudal and mediolateral oblique views, low energy (left) and recombined images (right) of the right breast in a 44-year-old woman show no artifact in low energy images, however, multiple vertical lines (white arrows) are present along the entire breast parenchyma in the recombined images due to incomplete CEM gain calibration prior to acquisition in the contrast enhanced mode.

Gain calibration artifact

Failed contrast-mode gain calibration prior to a CEM procedure can lead to significant artifact on RC images that severely compromise the image (Fig. 20).

Remedy: Adequate daily CEM recalibration of the system prior to beginning the acquisition. To avoid this, it's important to test the system on a phantom after any quality control step and before conducting a contrast enhanced imaging procedure.¹⁹

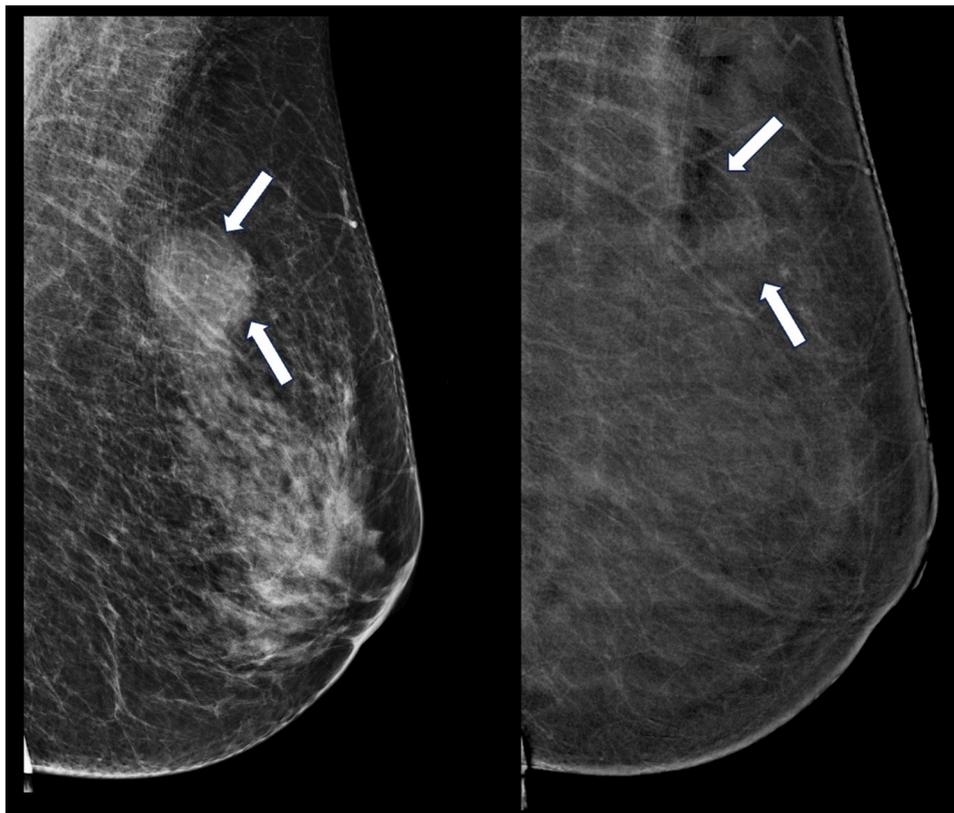
Fig. 21. Pitfalls in interpretation of contrast enhanced mammography, False negative interpretation; contrast enhanced mammography images in a 54-year-old woman with histopathologically proven mucinous carcinoma. Mediolateral oblique view, low energy image (left) of the left breast showing equal density round mass in upper breast with punctate calcification within (white arrows) and the recombined image (right) showing no enhancement of the malignant mass (white arrows).

compromising comprehensive local staging of malignancies. Multimodality imaging is often necessary to compensate for these limitations. Certain malignancies, such as invasive lobular carcinoma, mucinous carcinoma, and ductal carcinoma in situ (DCIS), may not exhibit enhancement on RC images due to their variable neoangiogenesis.^{2,8} (Figs 21, 22) Certain benign pathologies, such as fibroadenomas, sclerosing adenosis, papilloma, fat necrosis, post-surgical inflammation, and intramammary lymph nodes, may enhance in post-contrast images, potentially leading to false-positive interpretations and unnecessary biopsies (Fig. 23). Marked background parenchymal enhancement (BPE) can obscure underlying lesions, leading to false-negative results (Fig. 24). Intradermal lesions, like nevi and the presence of out-of-profile nipples, may also falsely mimic malignant masses (Figs 25, 26). Relying solely on RC images can result in false negatives, making it essential to base intervention decisions on the most suspicious findings across both RC and LE images. Correlating LE images to identify potential artifacts and utilising ultrasound where appropriate can enhance the specificity.

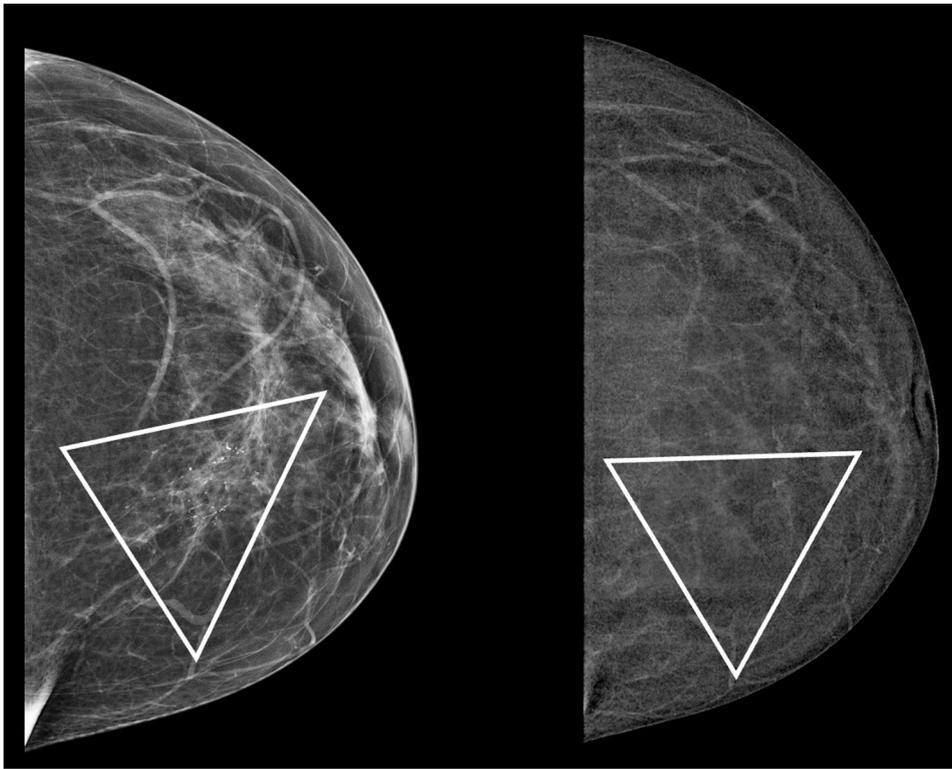
Fig. 22. Pitfalls in interpretation of contrast enhanced mammography, False negative interpretation; contrast enhanced mammography images in a 56-year-old woman. Craniocaudal view, low energy image (left) of the left breast shows fine pleomorphic calcifications in segmental distribution with no discernible mass and the recombined image (right) shows no enhancement, with subtraction of the suspicious calcifications seen on low energy image. Stereotactic vacuum assisted biopsy was done from the suspicious calcifications which revealed ductal carcinoma in situ (DCIS).

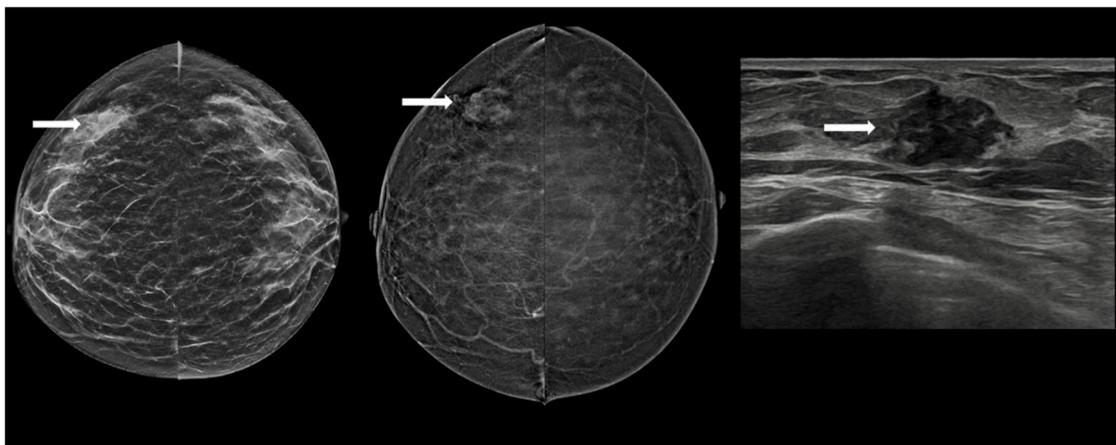
Fig. 23. False positive interpretation; contrast enhanced mammography images of a 46-year-old woman. Craniocaudal view, low energy image (left) of the right breast shows a subtle asymmetry (white arrow) in the outer right breast; recombined image (middle) shows heterogeneous enhancement within the mass (white arrow) and the correlative ultrasound image (right) shows an irregular hypoechoic mass whose margins are not circumscribed. Ultrasound guided vacuum assisted biopsy using 9-gauge needle revealed sclerosing adenosis with no in-situ component or invasive malignancy.

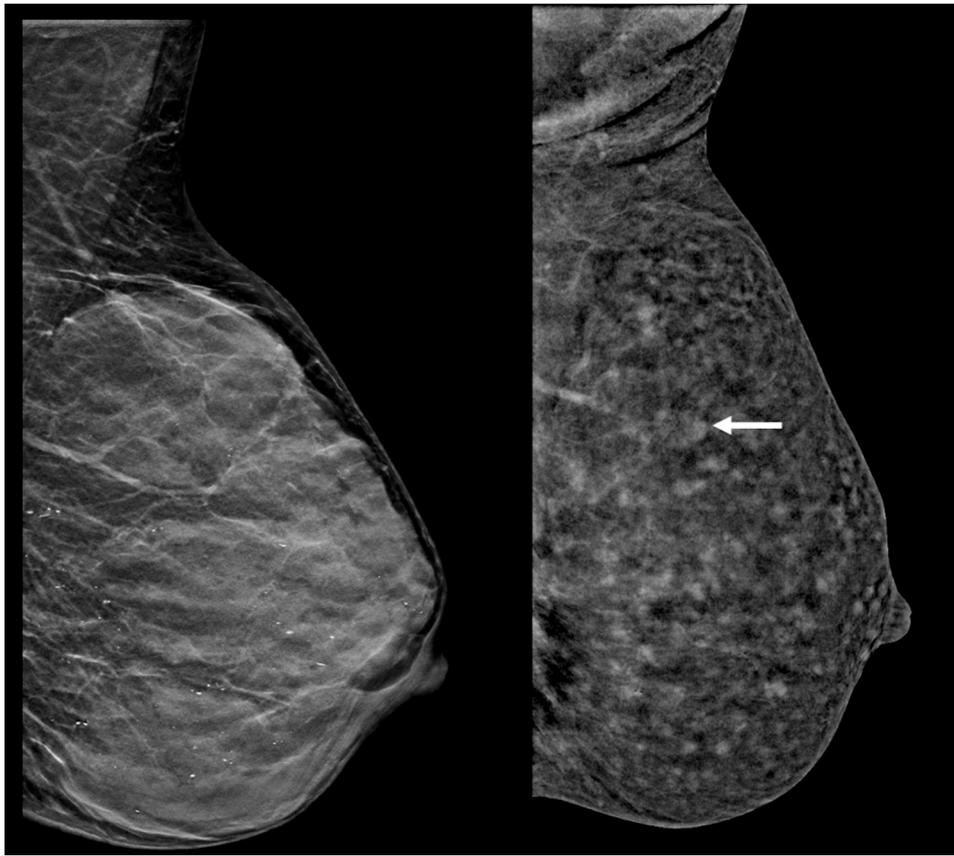
Fig. 24. False negative interpretation due to marked background parenchymal enhancement; contrast enhanced mammography images in a 38-year-old woman with bilateral breast pain and history of breast cancer in mother. Mediolateral oblique view, low energy image (left) of the left breast depicts extremely dense breast with diffuse round and punctate calcifications. Recombined image (right) shows marked background parenchymal enhancement which is potentially obscuring an oval circumscribed homogeneously enhancing mass in the upper breast, which was first detected on ultrasound and retrospectively located on the recombined image. The mass was biopsied under ultrasound guidance using 14-gauge needle, and histopathology revealed a fibroadenoma.
