Review Article

Optimizing contrast enhanced mammography: A comprehensive review of artefacts, causes, and remedies

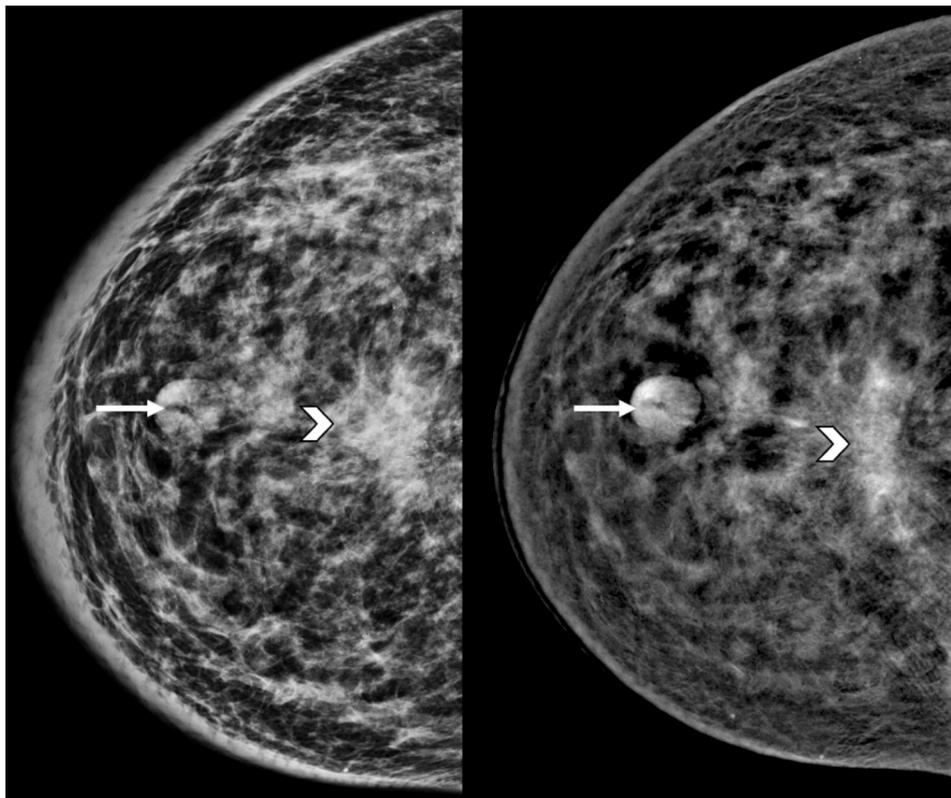
Fig. 25. False positive interpretation due to distorted enhancing nipple; contrast enhanced images in a 59-year-old woman with right breast swelling and palpable lump. Craniocaudal view, low energy (left) and recombined images (right) depicting enhancing irregular spiculated mass (white arrowhead) in the posterior third of right breast, with enhancement of the nipple mimicking as another enhancing mass in the central breast, creating potential pitfall in image interpretation.

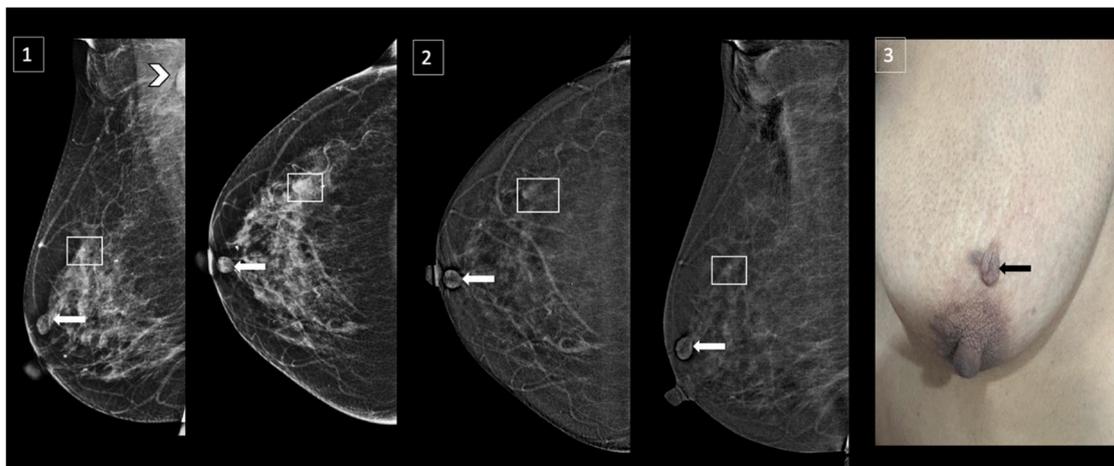
Fig. 26. False positive interpretation due to enhancing skin lesion; contrast enhanced mammography in a 60-year-old woman who came with right axillary lymphadenopathy which was proven as metastatic on fine needle aspiration cytology (FNAC).

1: Mediolateral oblique and craniocaudal views, low energy images, show an oval circumscribed equal density mass (white arrow) in the retroareolar location with partially visualised enlarged right axillary lymph node (white arrowhead). Additionally, another mass with indistinct margins is seen in upper-outer quadrant of the breast, which is better appreciated on the craniocaudal view (white rectangle).
